## The first large-scale indoor tropical garden with Brazilian native tree species: Challenges and lessons

This commentary reports the challenges faced and lessons learned during the formation of the first large-scale tropical garden inside a building with native tree species in Brazil. This garden, set entirely over cement slab, is inside the Albert Einstein Education and Research Center (AEERC) – Campus Cecília and Abram Szajman in São Paulo city, and comprises 11 tree species, ten of which are native to the Atlantic Forest. The indoor environment, in the shape of an atrium, is controlled and isolated from the external environment, which imposes a unique and new habitat for those tree species, especially considering that this garden is shared with people during their daily activities. Over one year, we followed the growth and development of 95 trees and noticed that the acclimation potential varied among species as well as the susceptibility to pest and disease outbreaks and low temperature (due to an imbalance in the air conditioning system), which were identified as the main limiting factors. Among the species monitored, *Lafoensia glyptocarpa* was the most sensitive to mites,

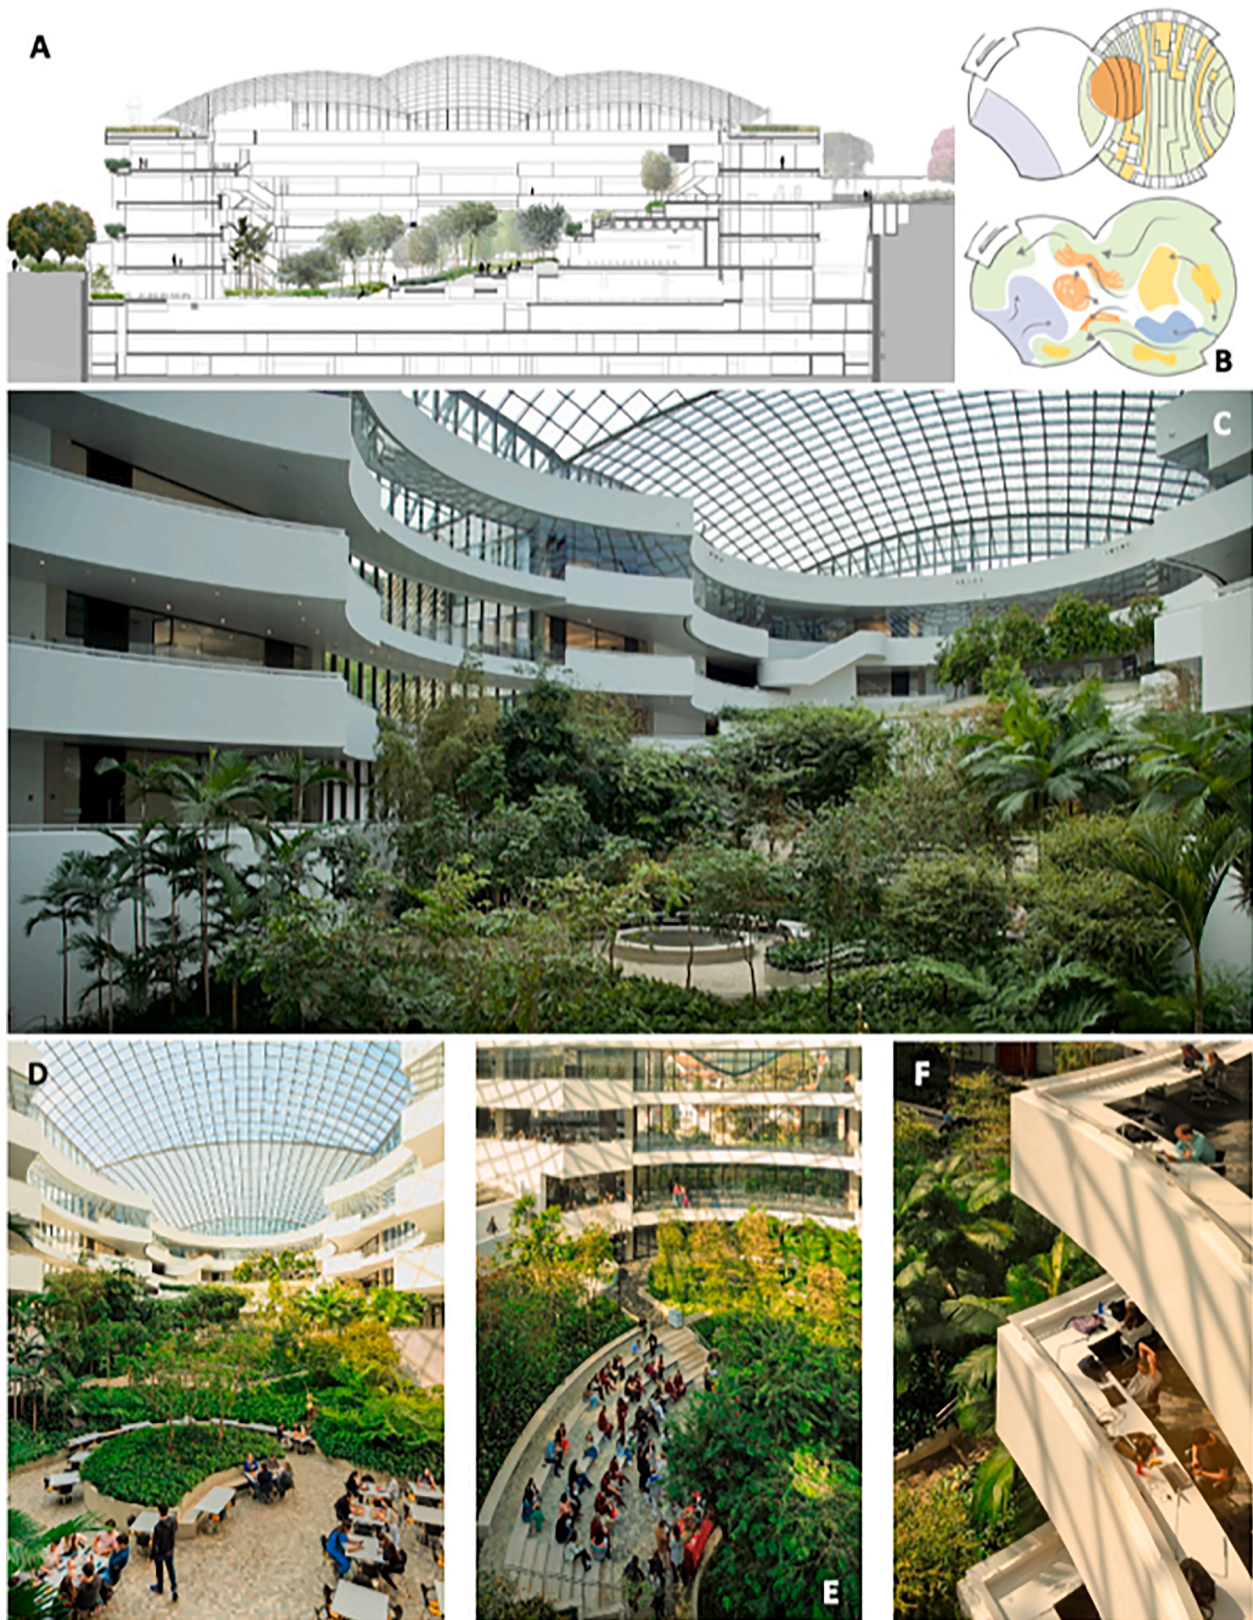
**Fig. 1.** (A) Longitudinal section of the building (West-East); (B) Atrium garden - schematic plans: above: initial design from the architecture team; below: redesign proposal by the landscape team, with planting areas in green, living areas in yellow, restaurant area in light blue, amphitheater in orange and with arrows indicating the expansion of the garden towards the restaurant area; (C) Atrium garden seen from an upper level. Photo: Manoel D. Leão Neto; (D) General view of the atrium garden, with the restaurant in the foreground. Photo: Fernando Guerra; (E) Atrium garden - amphitheater. Photo: Fernando Guerra; and (F) Studying areas surrounding the atrium garden. Photo: Fernando Guerra.

laboratories, conference rooms, an auditorium for 400 people and other facilities for carrying out state-of-the-art research (Grunow, 2022), with all of these environments surrounding the atrium garden (Fig. 1). In fact, such an indoor garden is the first one designed almost entirely with tree species native to Brazil inside a controlled environment.

species bring a dynamic and different perception of light and shade to the spaces created in the garden (Fig. 1C), attracting the public's attention and allowing for a possibility of sensations, calming, restful, promoting creative thought and harmonic togetherness of trees and people.

The indoor garden occupies an area of 1320 m<sup>2</sup> (Fig. 1C), of which 700 m<sup>2</sup> is the planting area, and it is basically divided into three levels: the lower level, with the restaurant (Fig. 1D); the intermediate level, with a small water feature and an amphitheater (Fig. 1C,E); and the upper level, close to the main entrance (Fig. 1A, right side). This indoor garden ended up becoming the central space of the whole building, acting as an interactive environment in which students, researchers and visitors can enjoy an open space to discuss ideas, refresh their minds, and have a coffee break and even meals at the restaurant (Fig. 1D-F). Recently, Oh et al. (2022) reported that frequent garden visitors identified themselves as a part of nature, and those who enjoyed being in nature had stronger social cohesion. This was the overall aim of the indoor garden inside the AEERC. In fact, fewer opportunities to experience nature in cities may reduce opportunities for social engagement and weaken social cohesion (Oh et al., 2022).

Enabling this indoor garden has only been possible because the landscaping project started concomitantly with the architectural project (Fig. 1B), which was key to guaranteeing that the plant needs were prioritized during the process, considering all the necessary adjustments in consulting projects, such as structure, irrigation, high-pressure misting, lighting, drainage, and electrical and plumbing engineering. For instance, given that the whole indoor garden was set on cement slab, the structural project was meticulously designed to meet the soil and vegetation load requirements as well as to guarantee the necessary soil depth and free horizontal spread (free of upstand beams) for the development of the plant root system. The landscaping project has even proposed to increase the planting area and replace the narrow planters that were initially proposed in the architectural project, redesigning the atrium geometry to allow the use of trees and to be able to create living spaces and walks (Fig. 1B), so that the space would be a "place" to be lived and enjoyed, not just a contemplation garden with an amphitheater. Another aspect carefully considered during the project was the necessary air temperature and relative humidity ranges that would contemplate both the well-being of people and plant development. The target was set at approximately 24 °C for the temperature and 60 % for relative humidity (not lower than 50 %).
